# DEVELOPMENT OF A LOW COST GRAPHITE REINFORCED COMPOSITE SECONDARY STRUCTURAL COMPONENT

FINAL REPORT
JUNE 1974— MARCH 1977

GENERAL DYNAMICS

Convair Division

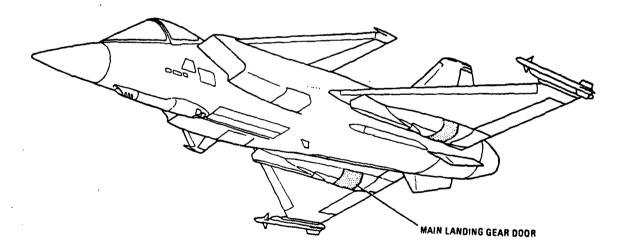
Figure 1-1. Convair Model 200 Navy V/STOL Fighter - Attack Aircraft

The component selected for evaluation was the main landing gear (MLG) door of the Convair Model 200 Navy V/STOL fighter-attack aircraft (Figure 1-1). The Model 200 as proposed to the United States Navy incorporated elevons, rudders, speed brakes, wing structure, canard, and lift engine compartment doors of advanced, high-efficiency composites because it was realized that agility and response in takeoff and landing, acceleration, and range or store carrying capability would be further improved by more extensive incorporation of these efficient structures.

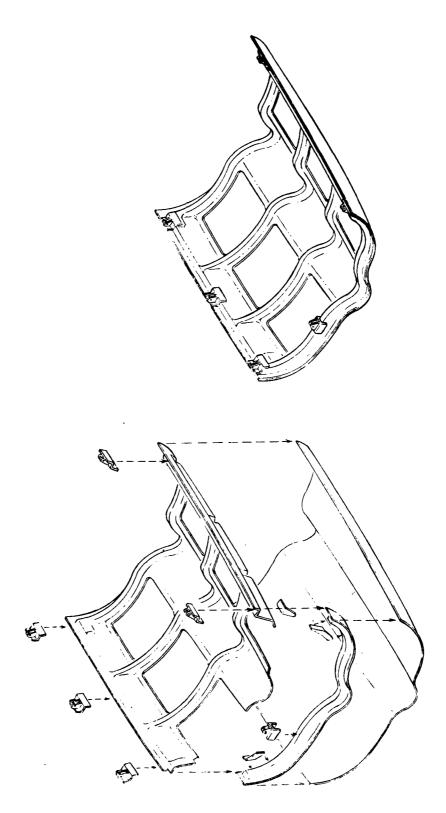
Figure 3-3, Graphite Thermoplastic MLG Door, Concept 1- Metal Replacement

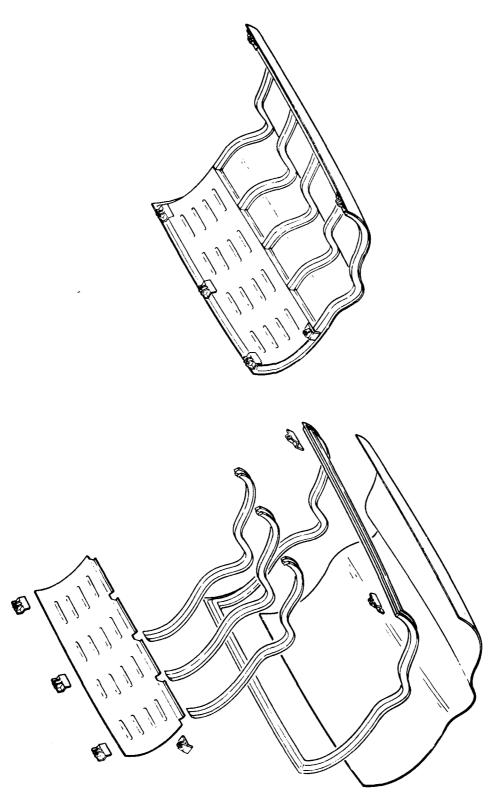
Figure 3-4. Graphite Thermoplastic MLG Door, Concept 2 - Partial Inner Skin

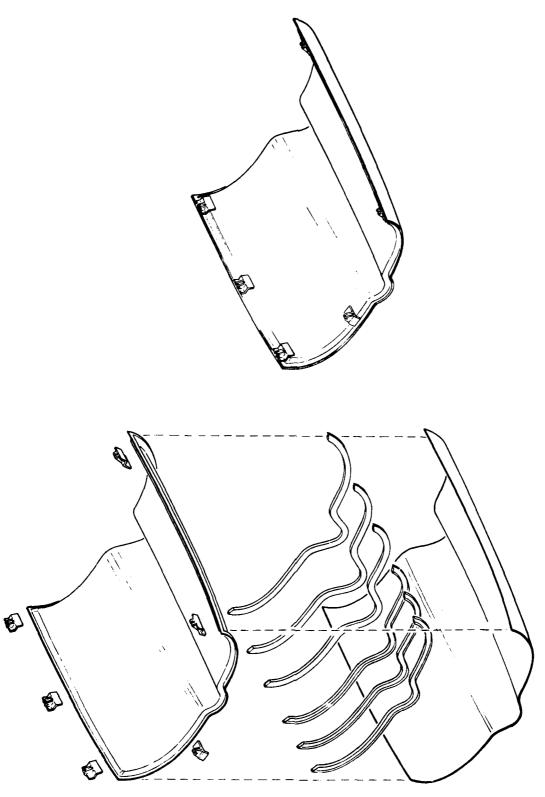
Figure 3-5. Graphite Thermoplastic MLG Door, Concept 3 - Full Inner Pan

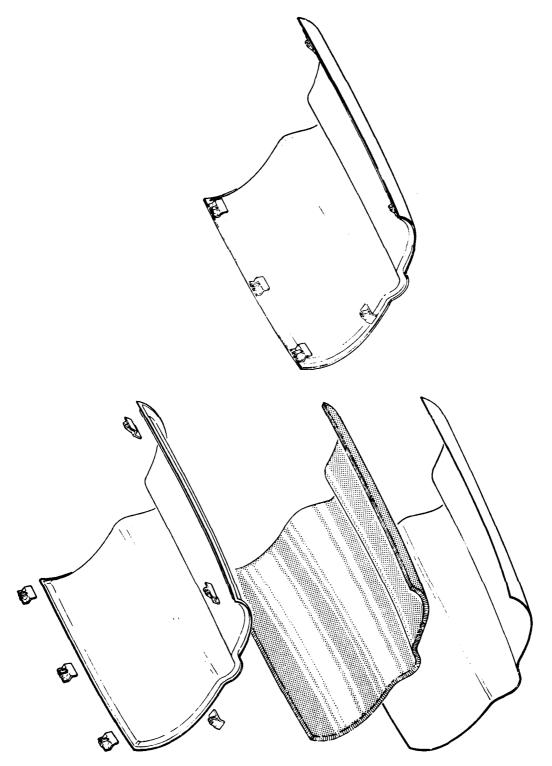
Figure 3-6. Graphite Thermoplastic MLG Door, Concept 4 - Sandwich Construction

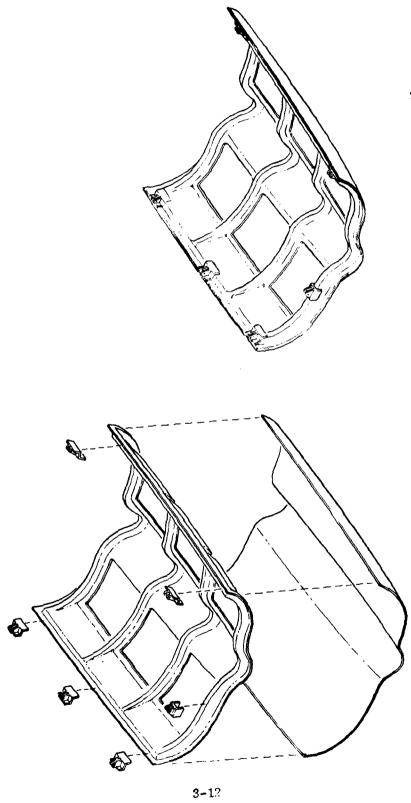
Figure 3-7. Graphite Thermoplastic MLG Door, Concept 5 - Two Piece Construction

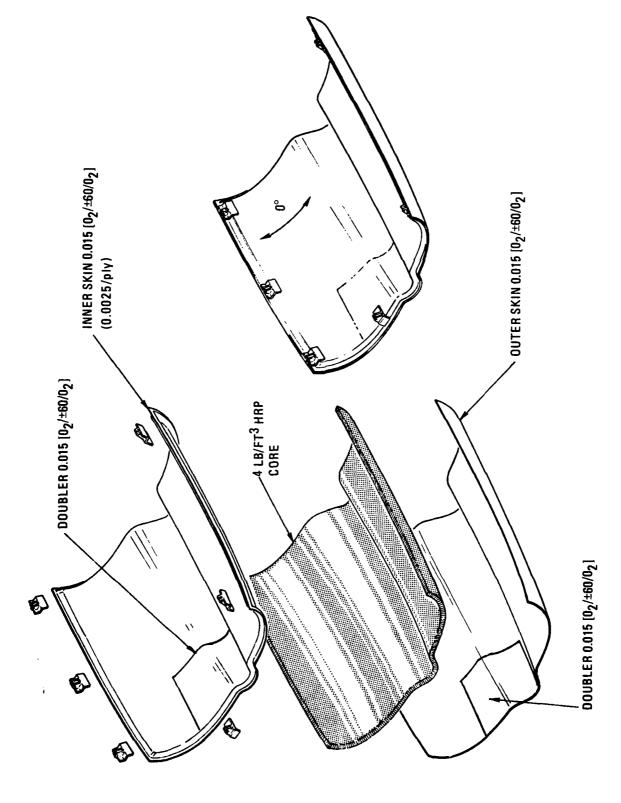
Figure 3-8. Minimum Weight Sandwich Door

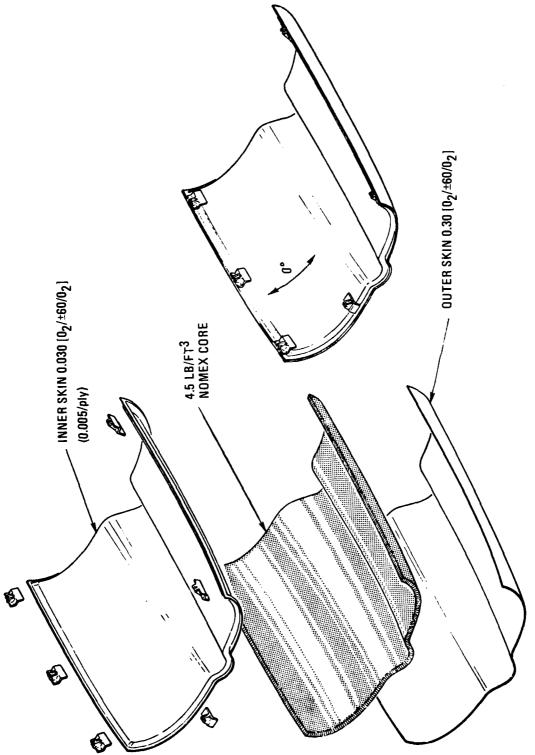
Figure 3-9. Practical Sandwich Door

Increasing the skin to a constant 0.030 inch on both facesheets allowed the use of conventional 0.005-inch/ply prepreg and provided an inherently more damage-tolerant structure. The weight penalty of this more practical approach was warranted considering the environment to which the MLG door will be exposed. Figure 3-9 illustrates this configuration.

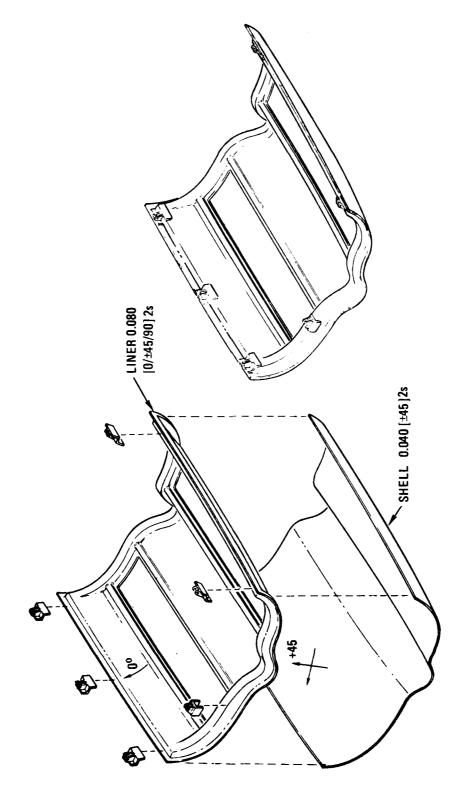
Figure 3-10. Graphite Thermoplastic MLG Door Shell/Liner Construction

Deflections under the door-open condition are quite large for the skin/liner configuration as was the case in the sandwich configuration. The free corner of the door deflects 4.1 inches in the z-direction (down) and 1.45 inches in the y-direction (aft). Figure 3-10 shows the configuration and skin layups of the chosen configuration.

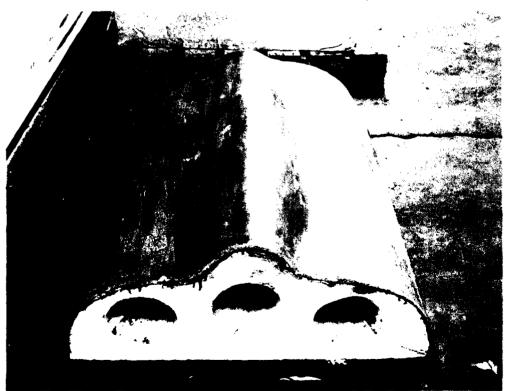
Figure 4-1. Full-Scale Skin Panel Ceramic Tool

The ceramic tool was cleaned with solvent, and Frekote 33 release agent was applied. Sheet stock was then held in place using glass tape. Armalon and bleeder cloth were then placed on top of the consolidated sheet. Silicone rubber bagging material was then attached to the ceramic die and vacuum (28 inches of mercury) was applied. The vacuum pressure pulled the flat sheet stock down to the contour of the ceramic tool. Thermocouples were then applied, and the tool was placed in an air oven and elevated to 500F while maintaining vacuum pressure. The tool was then removed from the oven and cooled to below 300F. Vacuum pressure was then released and the formed parts removed. Figure 4-2 shows the skin formed. Initial evaluation indicates that the parts were in the configuration required with full consolidation. It was determined later, however, that it was necessary to use autoclave pressure to form the full-scale skin due to the increase in size over the subelement skin section.

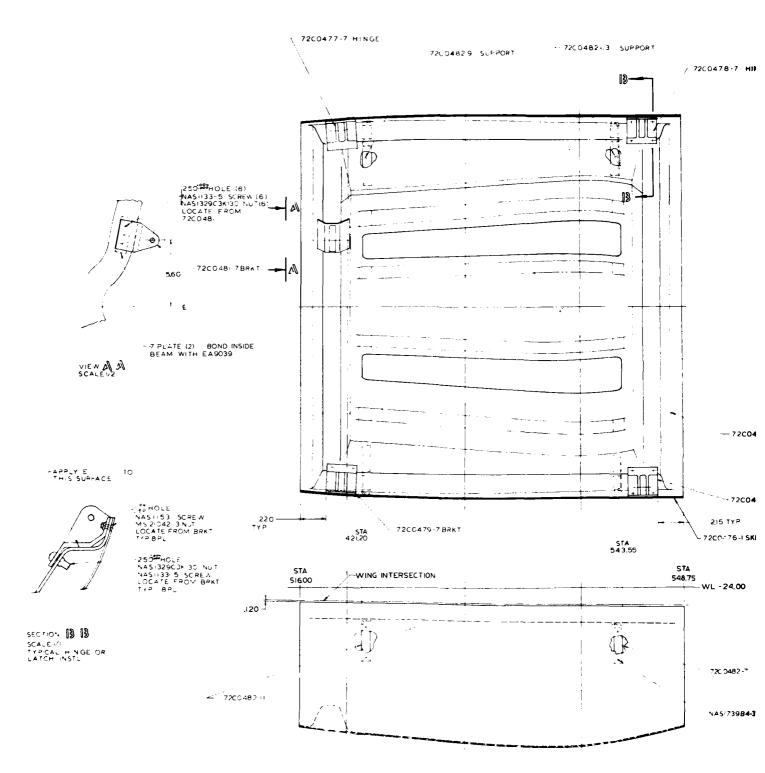
Figure 5-1. Graphite Thermoplastic Main Landing Gear Door Assembly

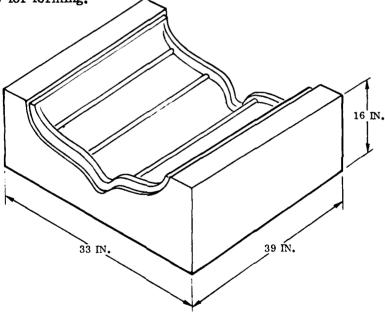
Figure 6-1. MLG Liner Tool

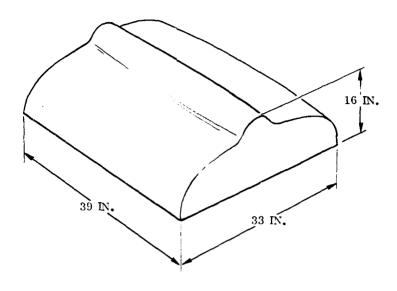
Figure 6-2, MLG Skin Tool

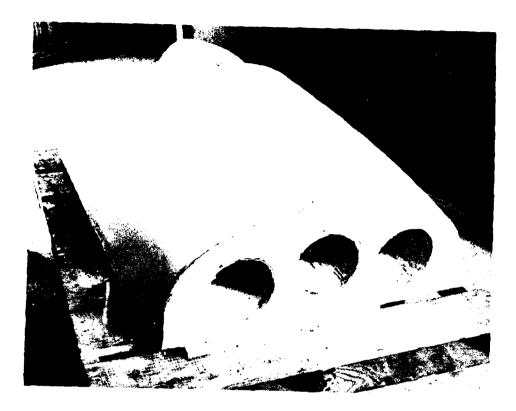
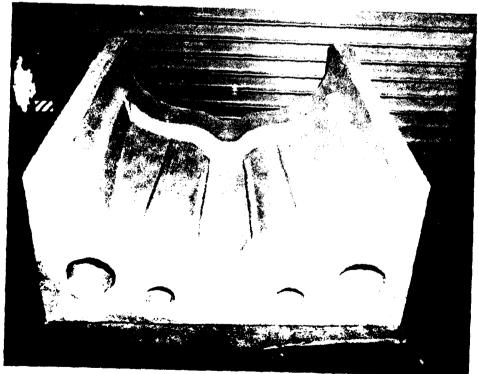
Figure 6-5. Completed Ceramic Tools after Casting

Casting setup of the ceramic tools was accomplished by placing side boards on the plaster cast and inserting a six-inch-diameter tube through the length of the setup. The tubes were used to reduce the quantity of ceramic and thus the weight of the ceramic tools. The surface of the plasters and the sideboards were then waxed with release agent and the ceramic mixed and poured. A single mix of ceramic was used for casting each tool so that no interfaces were present to reduce strength. After casting, the tool was covered with plastic and given a 72-hour, high-humidity cure. At completion of the high-humidity cure, the sideboards were removed and the tools were given a 72-hour, room-temperature cure. At completion of the room-temperature cure, the tool was separated from the plaster pattern and given a 72-hour cure at 350F. The elevated temperature cure drives off the moisture giving final set to the ceramic. Figure 6-5 shows the completed ceramic tools after casting.

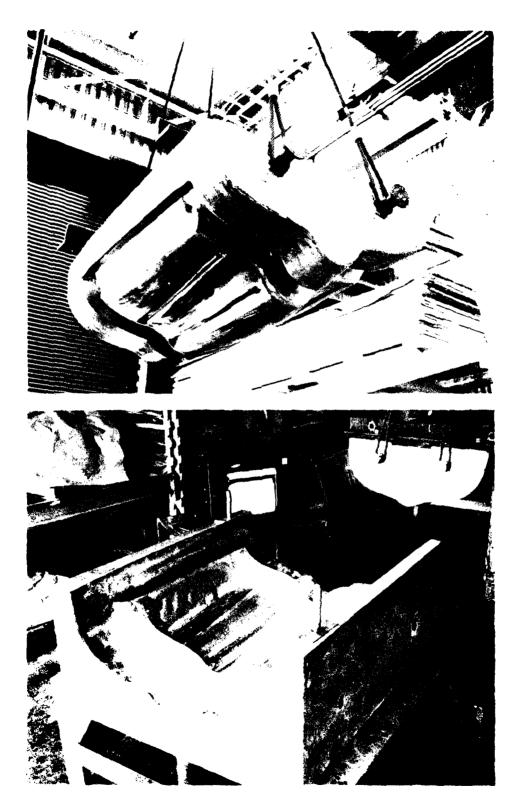
Figure 6-8. Complete, Matched-Set, Kirksite Tool

The process developed used a matched set of Kirksite dies to form a preform of the door liner. The Kirksite tools were heated in an air oven to 550F, a blank of prepreg material was placed in the female die, and the male punch was then placed on top to form the part in the same manner as if a press were used. When the temperature of the Kirksite reached 300F, the dies were separated and the preformed part was removed. This was required to remove the part without cracking due to the difference in coefficient of expansion between the graphite/thermoplastic and Kirksite. Final forming of the part was then accomplished using the ceramic tool and 80 psi autoclave pressure at a temperature of 550F.

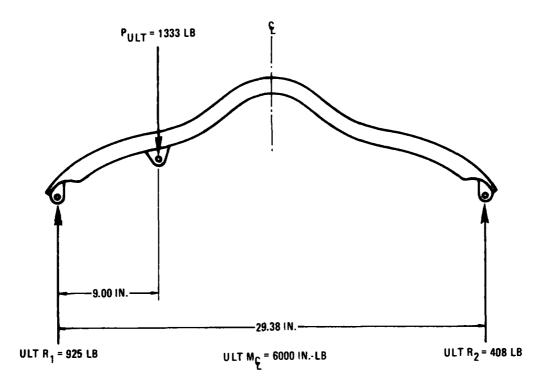
Figure 7-9. Beam Subcomponent Test Setup

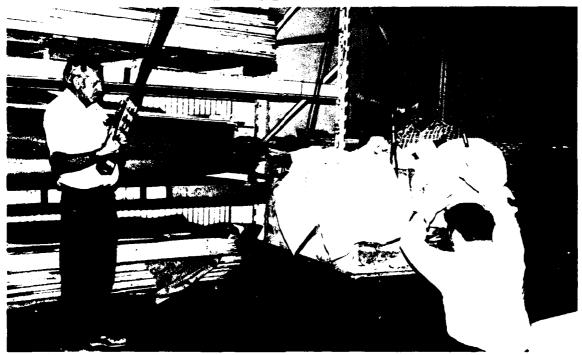
Figure 8-5. Forming of MLG Door Liner

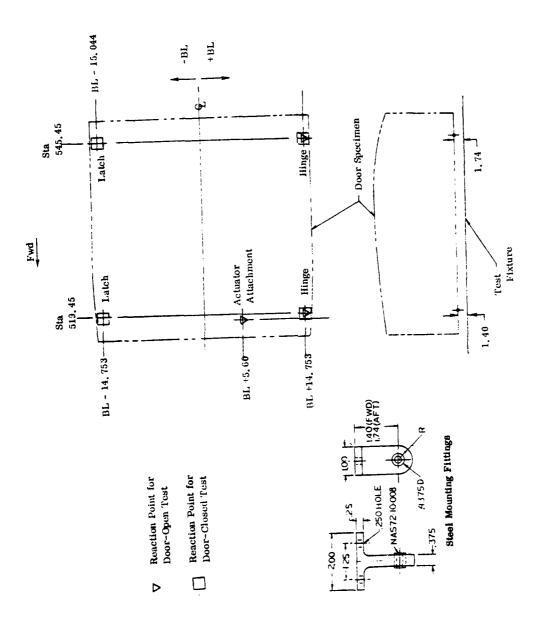
Figure 10-2. Test Setup

10.1.1 <u>DOOR-OPEN LOADING CONDITION</u>. The door-open test load distribution is illustrated in Figure 10-1. This constitutes an idealization of the Model 200 predicted service loading. The actual center of pressure is duplicated and the magnitudes were adjusted to preserve the total limit load of 1,532 pounds. The loads were applied normal to the door contour. Local intensities at the discrete pressure pads did not exceed 50 psi. With the door in the open configuration, the applied loads were reacted at the two hinge fittings and the single actuator strut which attaches to the forward beam. These locations are shown in Figure 10-2.

10.1.2 <u>DOOR-CLOSED LOADING CONDITION</u>. The applied test loads for the door-closed condition were equivalent to a uniform limit pressure of 240 psf acting normal to a theoretical flat plate of the same projected area as the door. This corresponded to a design limit load of 1,704 lbs. acting approximately at the mid-point of the door chord. The test loads were applied normal to the door contour and were suitably adjusted to permit vectorial resolution into vertical components having this summation. With the door in the closed configuration, the applied loads were reacted by the two hinges and the two latches. These locations are shown in Figure 10-2.

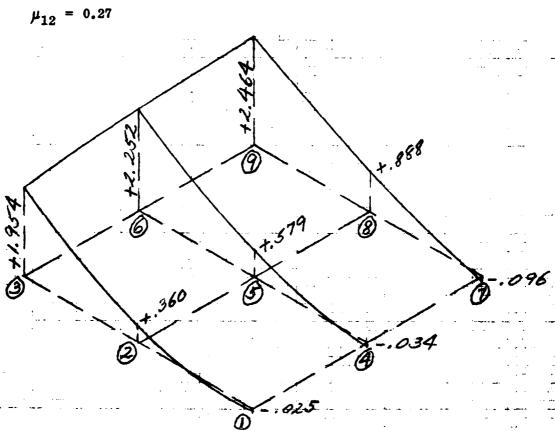
Figure 10-9. Deflection Surface for Door-Open
Configuration at 140 percent of Design
Limit Load

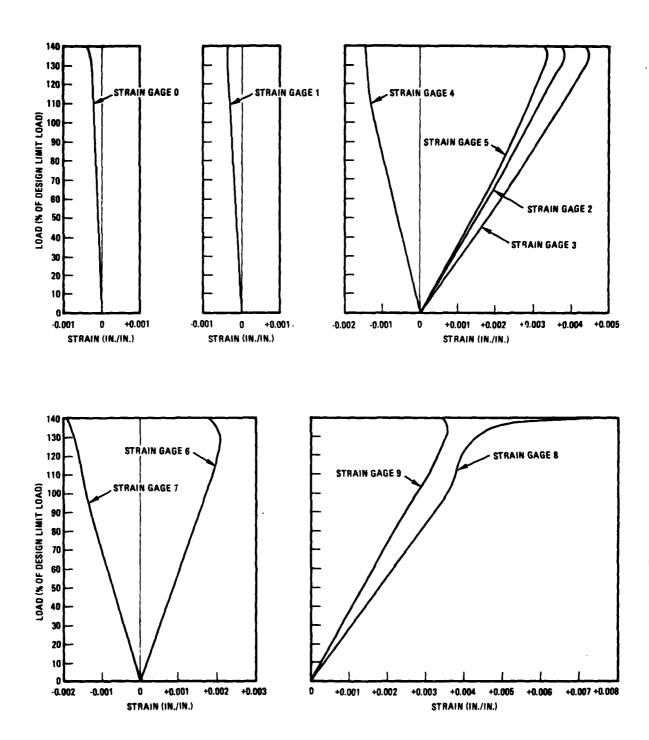
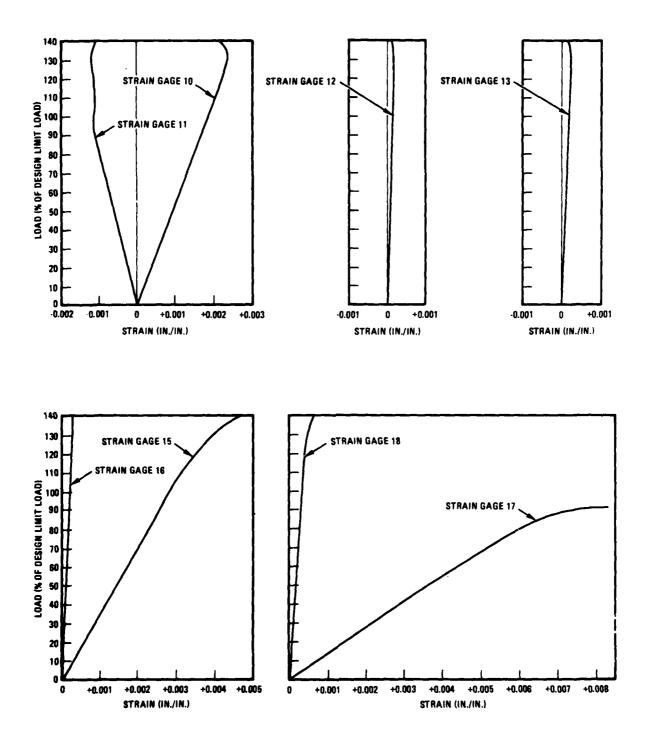
Figure 10-11. Strain Gage Data For Door-Open Test to Failure 10-11

Figure 10-11 presents plots of the measured spanwise strains in the forward and aft beams for the final door-open test during which failure occurred at 144 percent of design limit load. As expected, the values from gages 0 and 1 were very small since these gages were positioned in a region where the beam bending was predicted to be negligible. This is illustrated in Figure 10-11. The limit strains from gages 0 and 1 correspond to stresses of only -1,230 psi and -810 psi, respectively.

It was anticipated that gages 6 through 11 would all indicate a high degree of bending together with small net tensile forces acting parallel to the beam centerline. As shown in Table 10-1, the measurements fell far short of the predictions and would tend to indicate the presence of an unreasonably high net tension. It is thought that this is the result of the curved-beam phenomena described by Westrup and Silver in Reference 10-1. As noted there, induced radial loadings due to curvature can cause

From the plots of Figure 10-11, it is rather clear that strain gage 17 malfunctioned. At approximately 90 percent of design limit load, the strain appears to increase

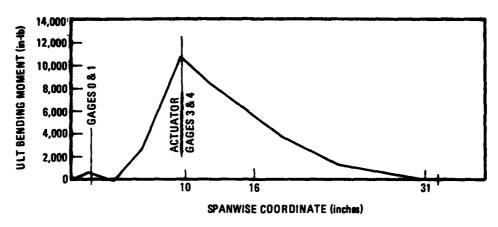
Figure 10-12. Predicted Bending Moment Diagram for Forward Beam with Door Open

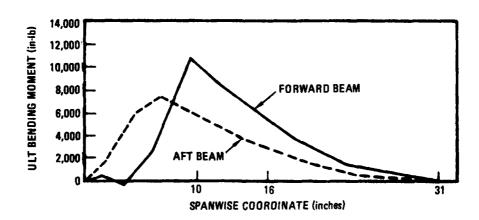
Figure 10-13. Comparison of Predicted Bending Moments in Forward and Aft Beams

Gages 15 and 16, which are located on the aft beam, conform with the anticipation that the bending moment for this beam would peak closer to the hinge line than would that for the forward beam. This relationship is illustrated by the superimposed display of both moment diagrams in Figure 10-13.
